BUILDING SURVEY

Brentor Village Hall Brentor Tavistock Devon PL19 0LZ

Our Ref: VK/OGSW/CSS0419/1173 **Date:** 15th April 2019

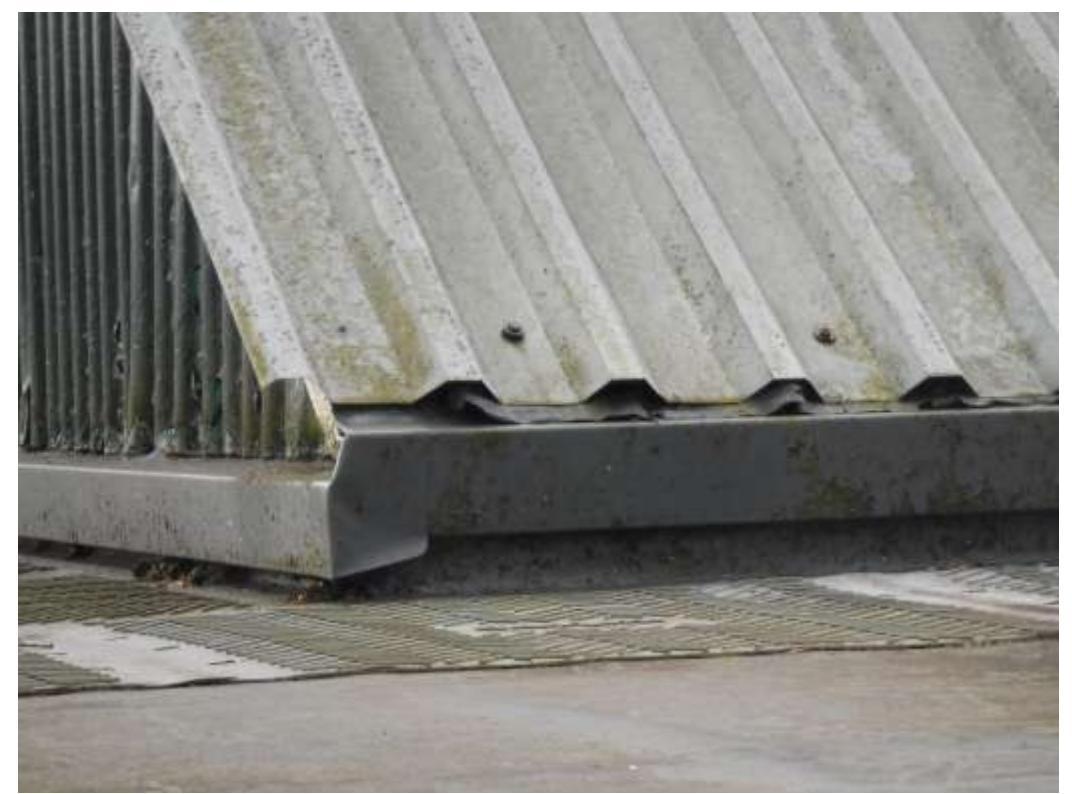
The fact that an untearable non-breathable underfelt has been provided underneath the corrugated metal roofing is of some concern as this will not allow for any condensation to escape. We have concerns that condensation rising up through the inside of the building will condense on the underside of this underfelt and then drip down onto the boards that line the underside of the roof, causing timber decay. We could see no damp stains on the boards and we have to assume that this is not a major issue, but there is of course every reason to believe that there could be timber decay hidden from view. This is an issue that will be very difficult to resolve without stripping and re-laying the corrugated metal incorporating an air gap underneath the felt to allow for ventilation. Alternatively a breathable underfelt could be provided, with an air gap over. The situation should be carefully monitored and, if you do find that there are any water stains on the boarded soffits, then remedial work would be recommended.

6. An untearable underfelt appears to be provided at the base of the metal roof finish.

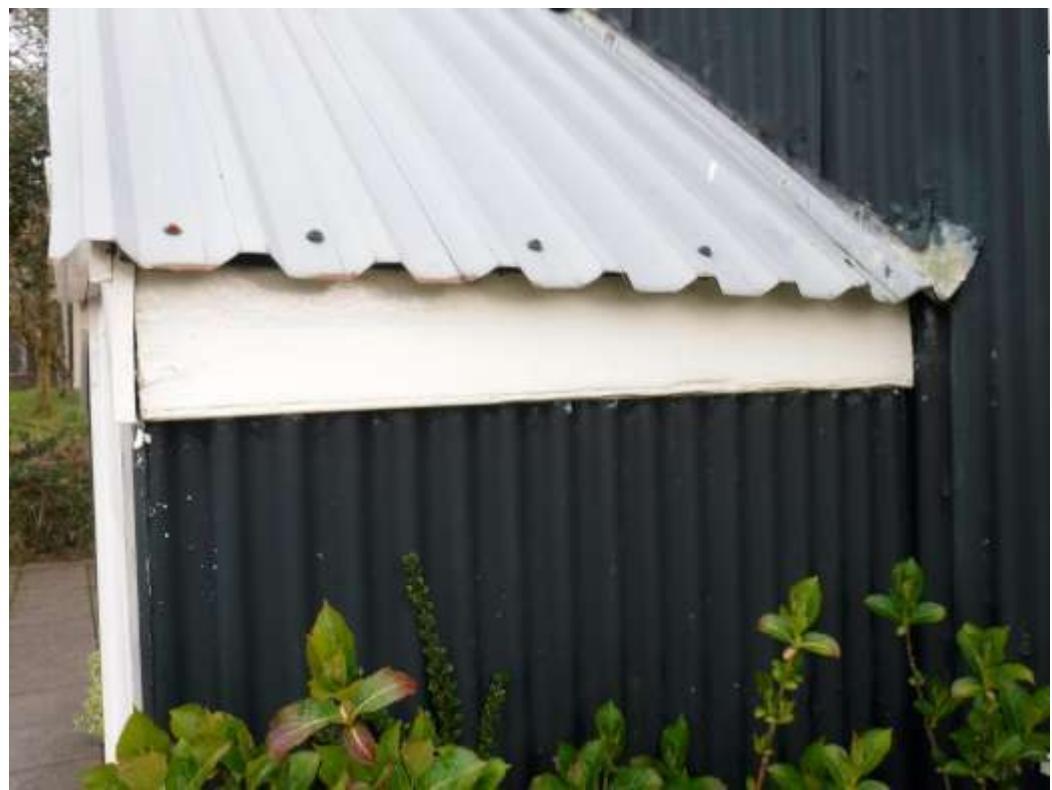
The roof coverings were all found to be in reasonable order. Some of the paint finish has started to deteriorate in places and some surface corrosion was noted on the metal, but no major defects were noted.

Timber fascia boards and barge boards have been provided at the property. These were generally found to be in reasonable order, although, timber decay has obviously started to affect the fascia board on the right hand side of the old porch at the front. Repairs have been carried out in the past, but further repairs will obviously be required when you next redecorate. You may find it most viable to replace this piece of boarding.

7. Example of corrosion affecting the metal roof finish; also note the left-hand fixing cap is missing. The fascia board here is affected by timber decay. Note fixings are provided through the lead flashing.

As a matter of course, we would recommend that you budget for taking off the fixing bolts, renewing the washers, and providing new covers over the bolts, as part of a planned maintenance programme, in the very near future. Non-ferrous fixings would be best used. Also, where corrosion has started to occur to the roof sheets, we would recommend that these are rubbed down and rustproofed prior to redecoration work.

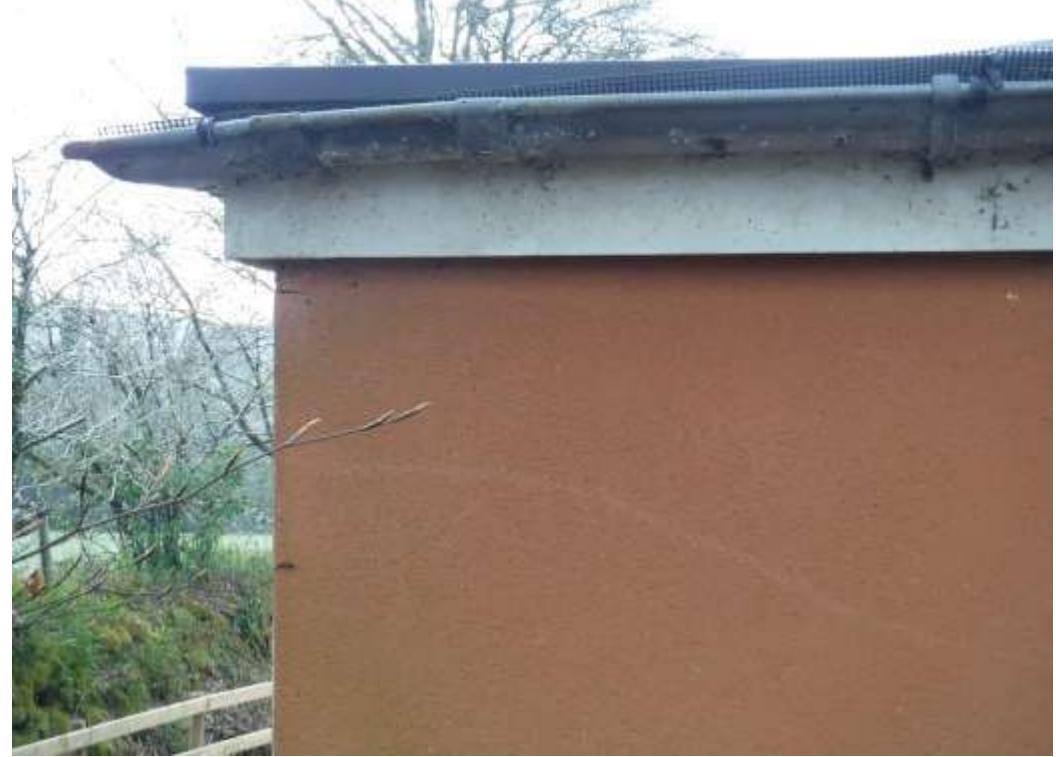
We did note to the rear left hand corner of the extension that the guttering system sags downwards. Here water has been collecting and the galvanising on the steel has started to break up and perforations have occurred.

8. The gutter in the corner here has dropped.

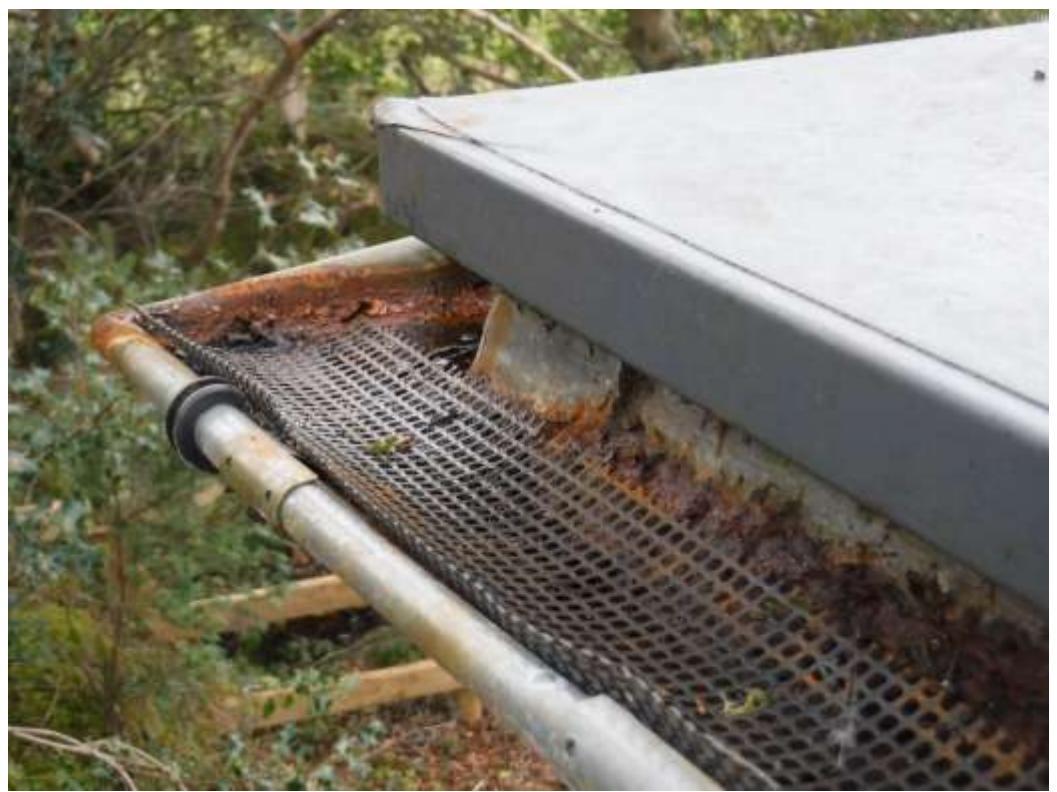
We could see a good deal of surface corrosion inside the gutters generally.

9. Significant corrosion has started to affect the guttering.

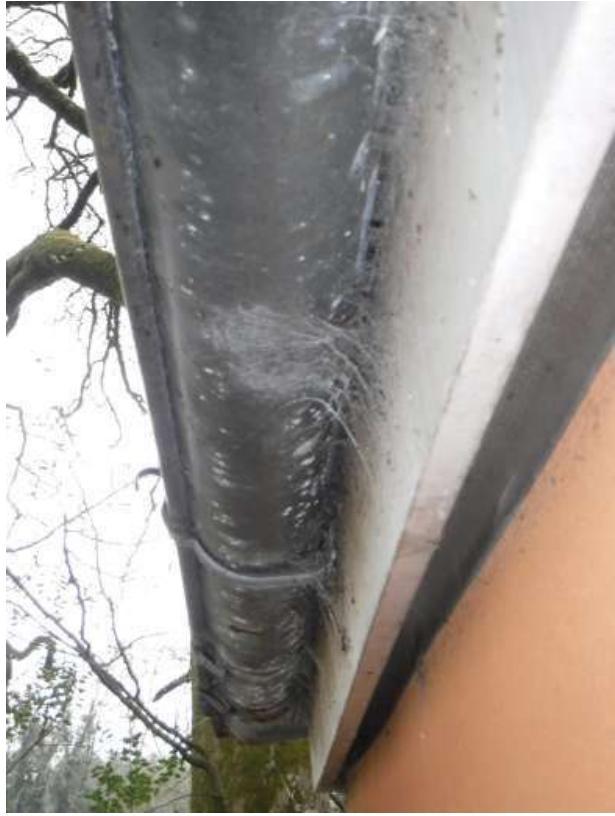
The perforations have obviously started to let water through and some sections of gutter will have to be renewed.

10. Corrosion has started to perforate the gutters.

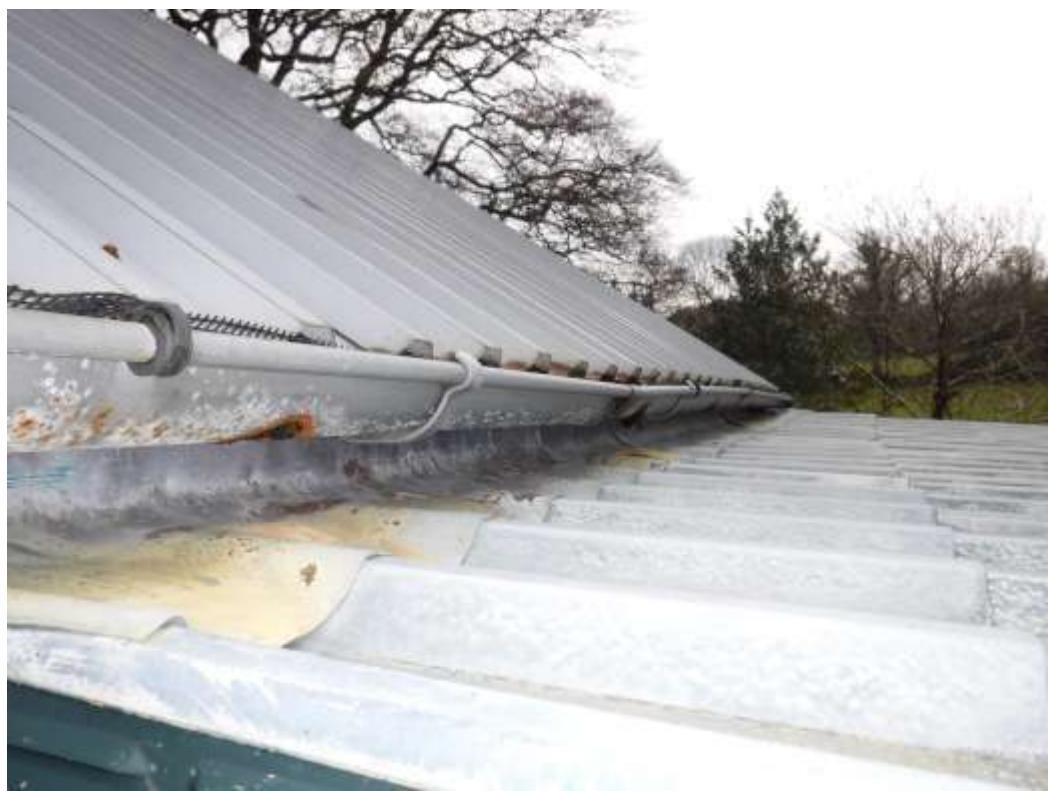
A number of holes have been drilled in the guttering system above the right hand lean-to roof. Presumably this has been done in an attempt to reduce the load on the main guttering system allowing some of the water to escape via the lean-to guttering system. There is corrosion around the holes, due to the galvanising having been damaged when the holes were drilled.

11. Some holes have been drilled in the guttering; here corrosion has started to result.

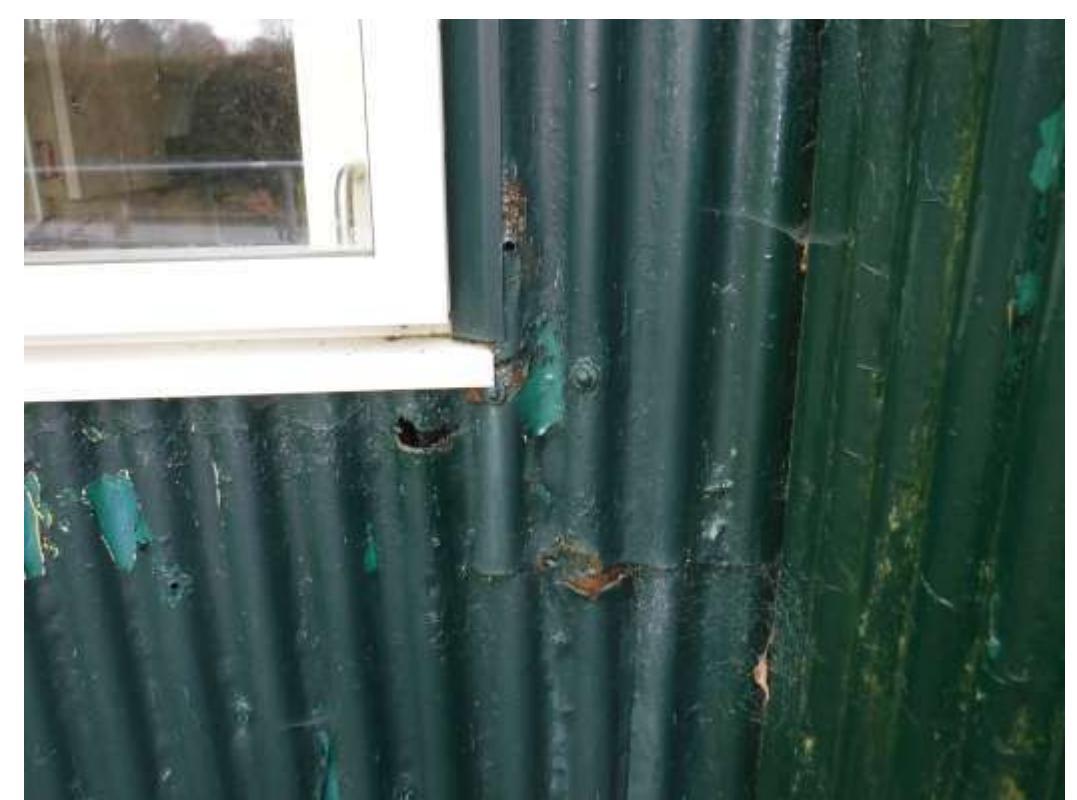
12. Damage noted to the corrugated metal cladding here.

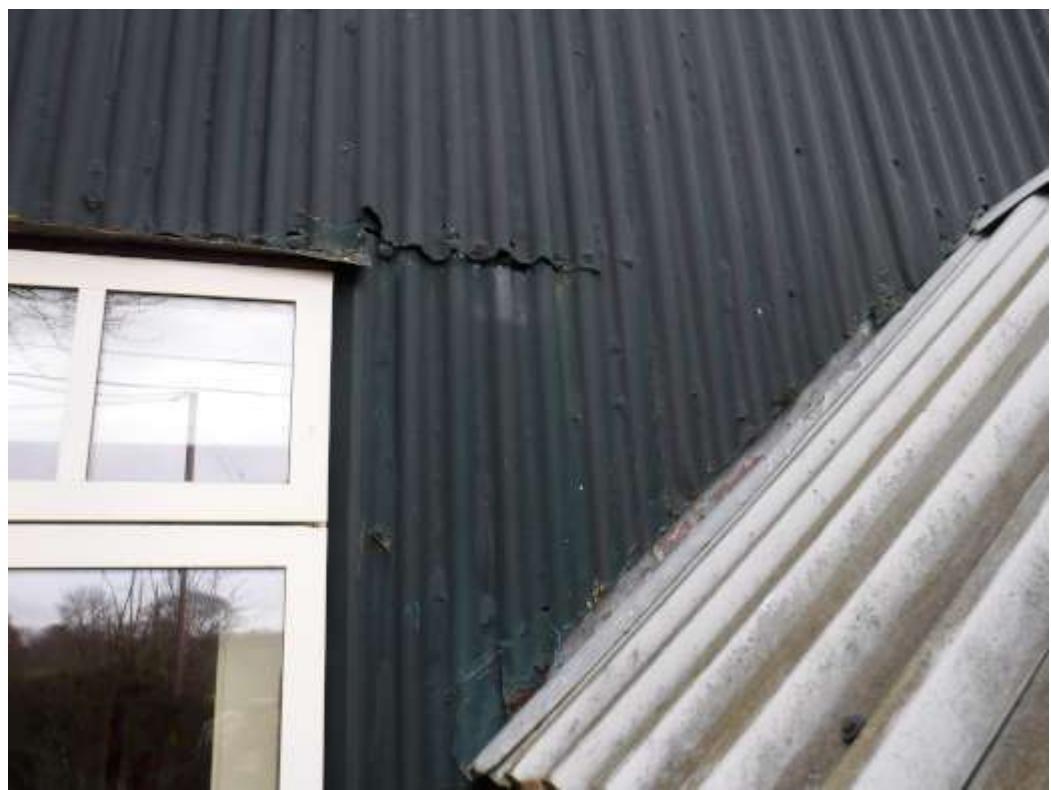
13. Damage noted to the corrugated metal cladding here.

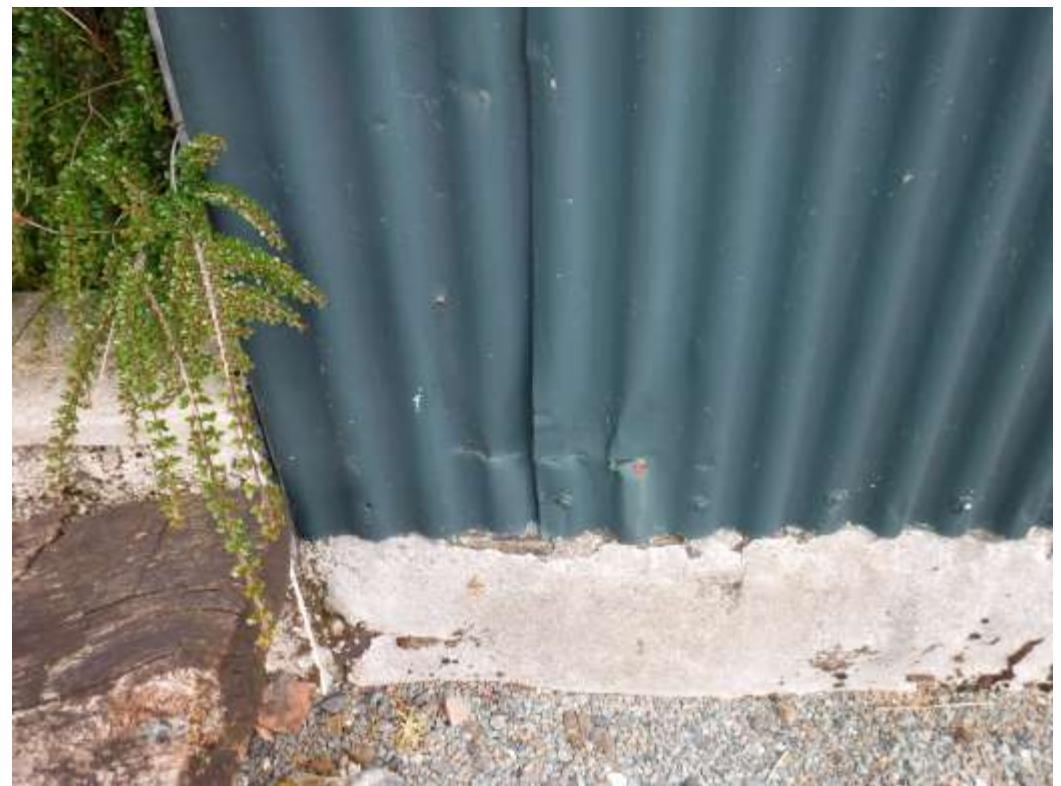
Where the patio area at the front wraps around the right hand side of the front right hand planter, there are some paving slabs and underlying concrete which meet up with the corner of the building here, and penetrating damp could be causing issues here as well. When the corrugated iron is being replaced, we would recommend that some form of damp-proofing system is provided between these two elements.

14. Crack noted through the corrugated metal cladding here; The high level of the patio could be causing dampness inside.

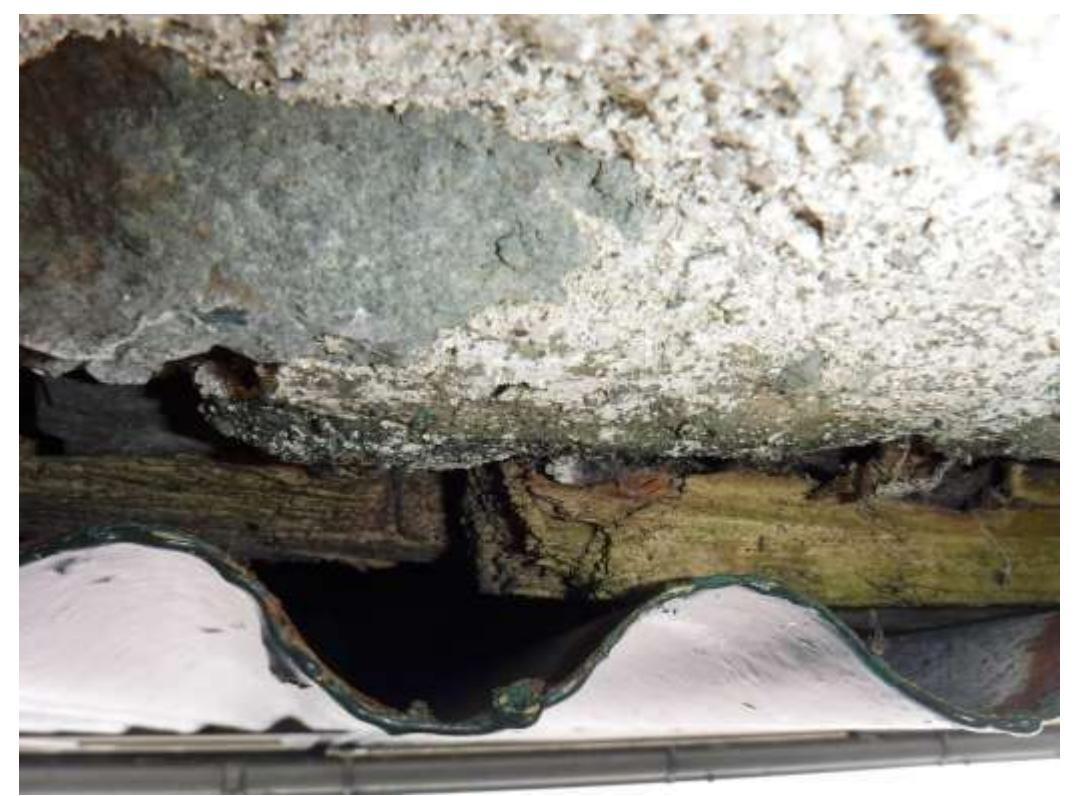
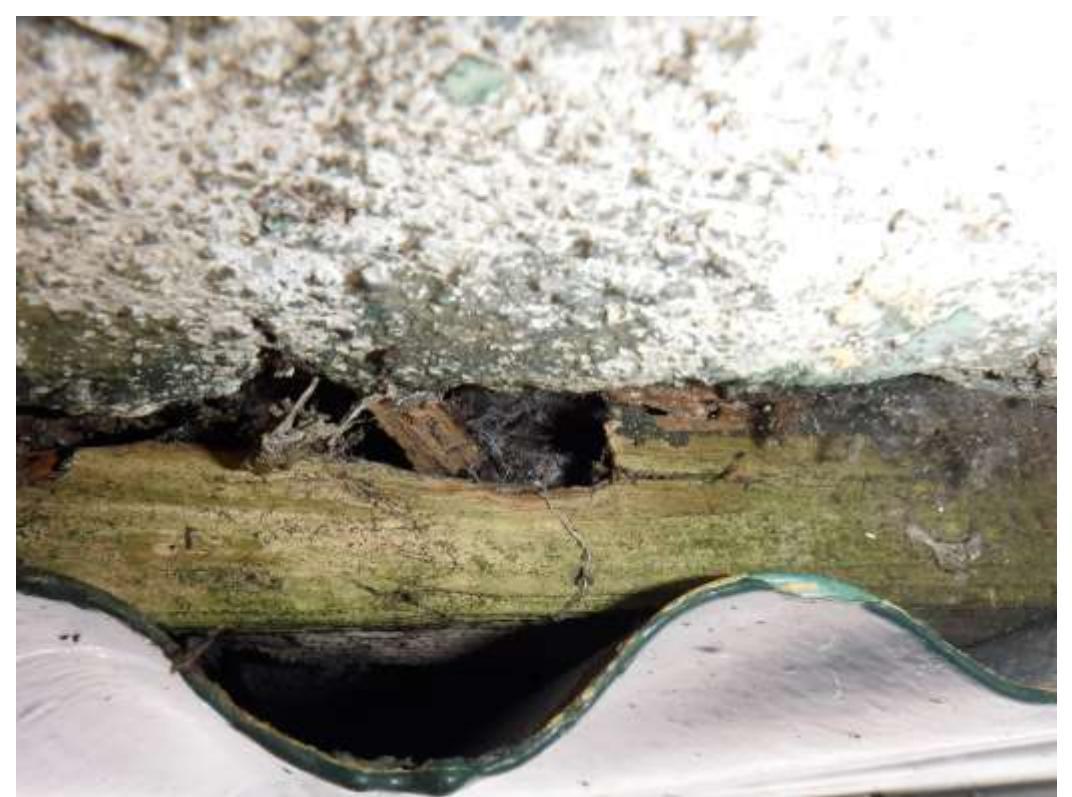
We did note a slight drop in the level of the floor in the front right hand corner of the main hall area. We did manage to get a floorboard up here and we did find timber decay in the base of the framework at the bottom of the front elevation wall here. On each side of what was once a front porch, there are planters and the level of the earth here will tend to rise up over time. Whilst some timber battens have been installed in an attempt to contain the flower borders, these have obviously not been particularly successful and the high level of the earth here is the main issue. We did note that the floor in the front right hand corner of the hall drops downwards slightly, probably for the same reason. We did note an airbrick underneath the right hand window on the front elevation, but this has been covered up on the left hand side. We would recommend that these flower borders are completely removed and dug out. They can then be taken down to a lower level and some gravel can be laid in these areas, and then, if desired, plant pots could be put here. Needless to say, when you renew the cladding on the outside of the building, you will probably find that there are some quite significant timber repairs required in all of these areas.

18. Timber decay noted in the timber wall plate here.

19. Another view of the same decay.

Any timber decay found in the walls should be referred to a specialist, and works should be carried out by a specialist, under an insurance backed guarantee.

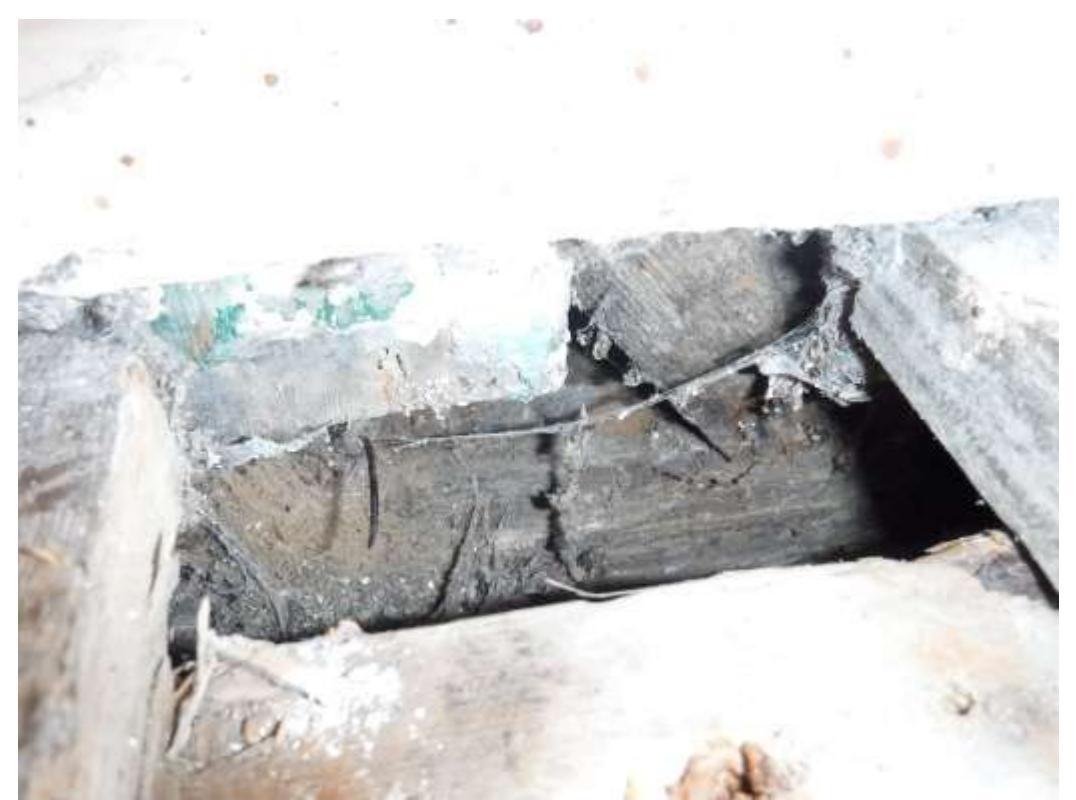
20. Timber decay noted in the timber framework to the front left-hand corner.

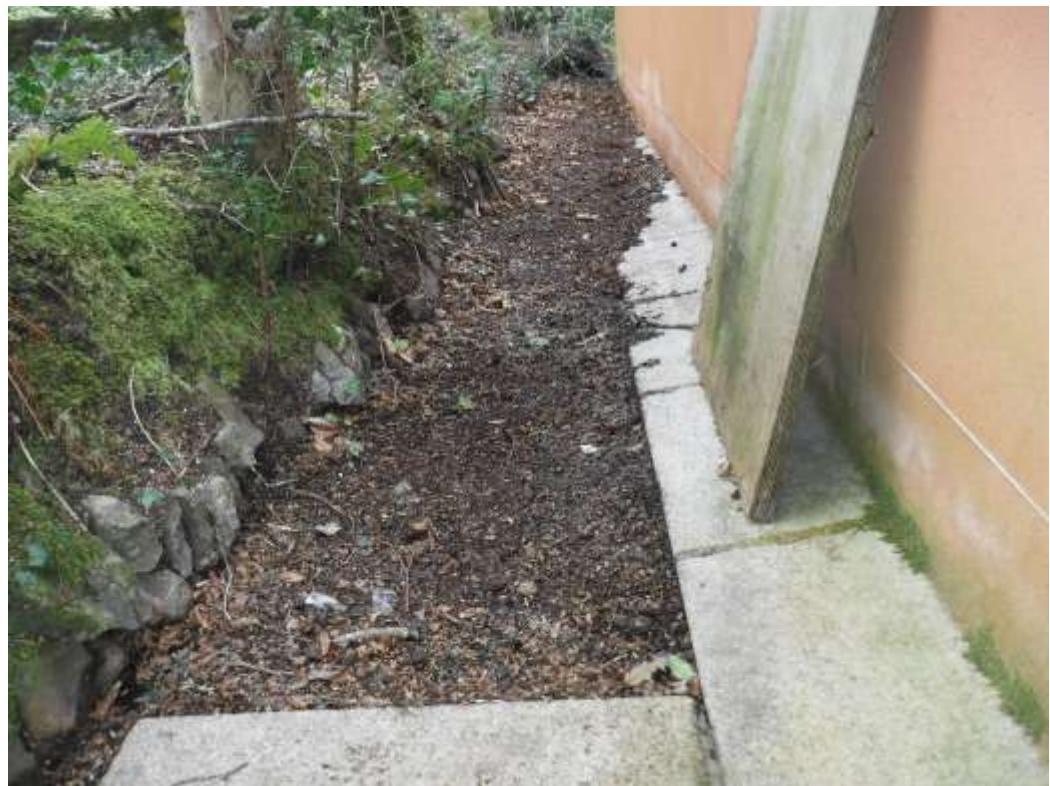
21. High ground level to the left-hand side.

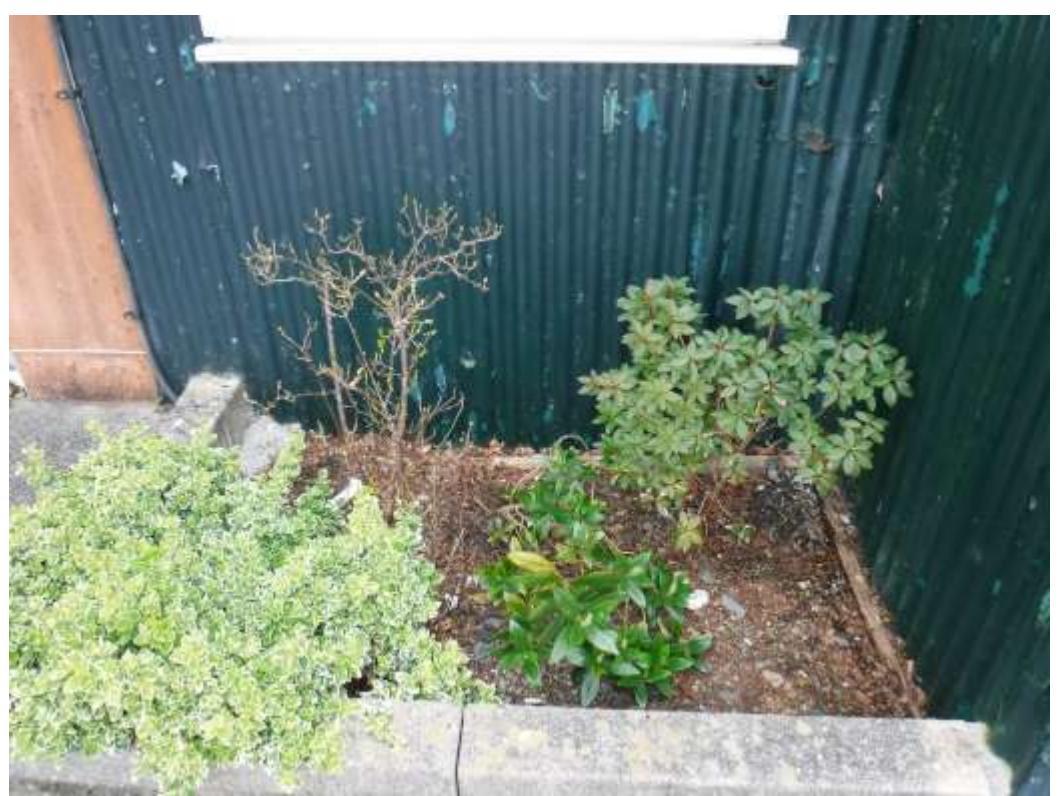
22. High ground levels to the left of the old front porch.

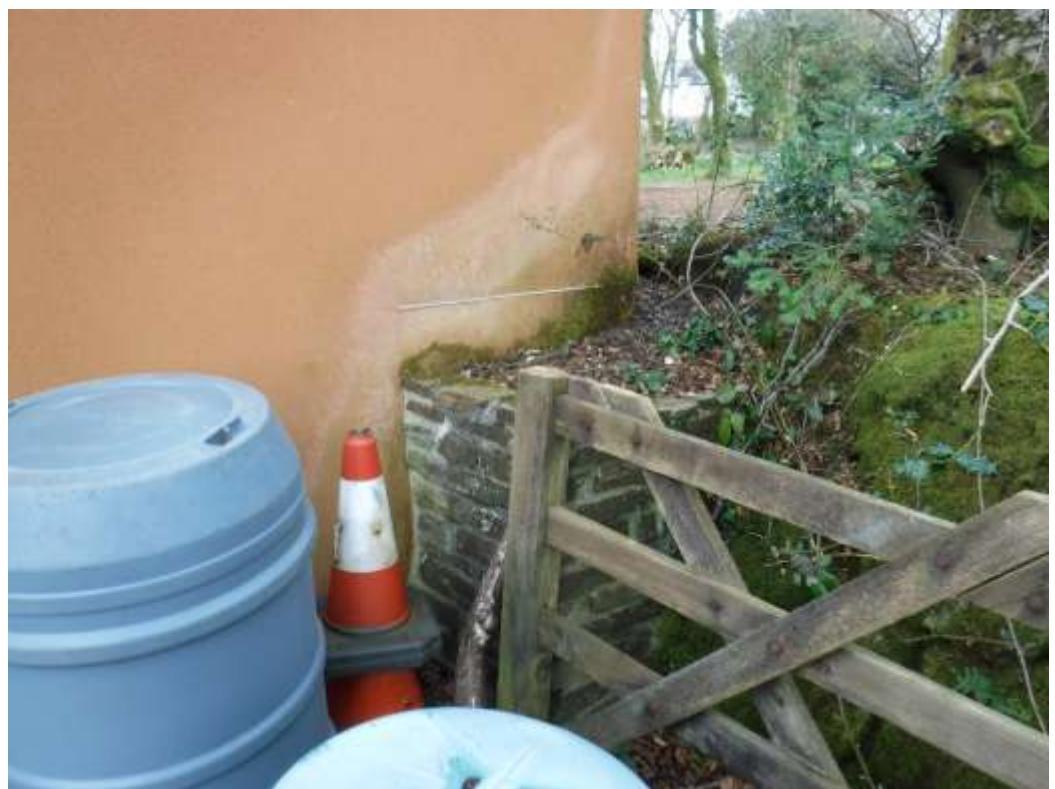
23. High ground levels to the rear left-hand corner.

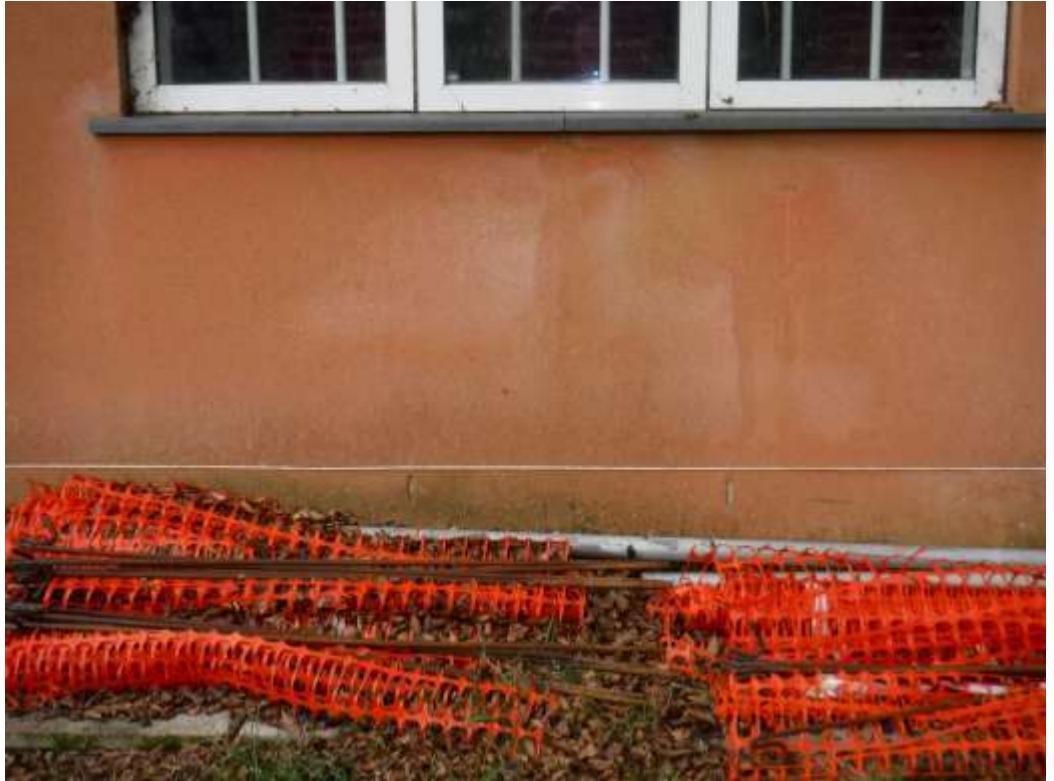
On the extension, we tapped external render at random accessible positions. We did not find any significantly hollow finishes, although, we did note some cracks, particularly around window/door openings. These cracks will generally have occurred due to thermal movement and repairs can simply be carried out when the property is being redecorated.

24. Cracking around window and door openings is not considered of major concern.

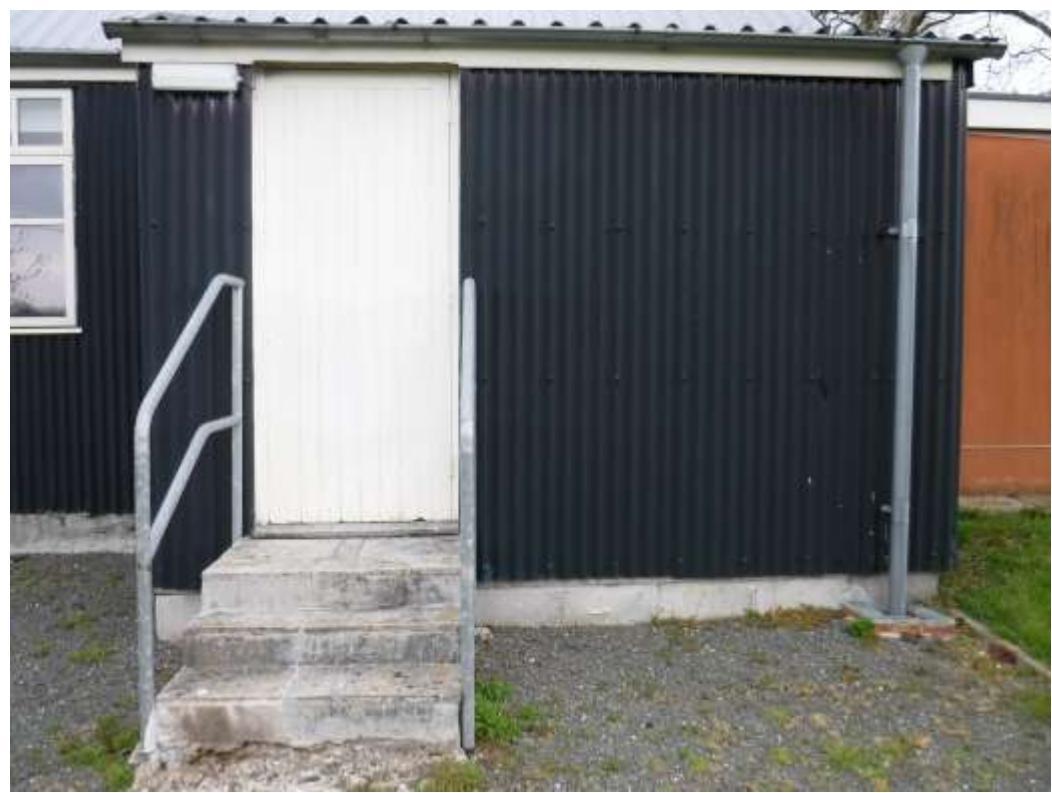
25. Timber decay noted at the base of the door frame and the door here; note very basic steps.

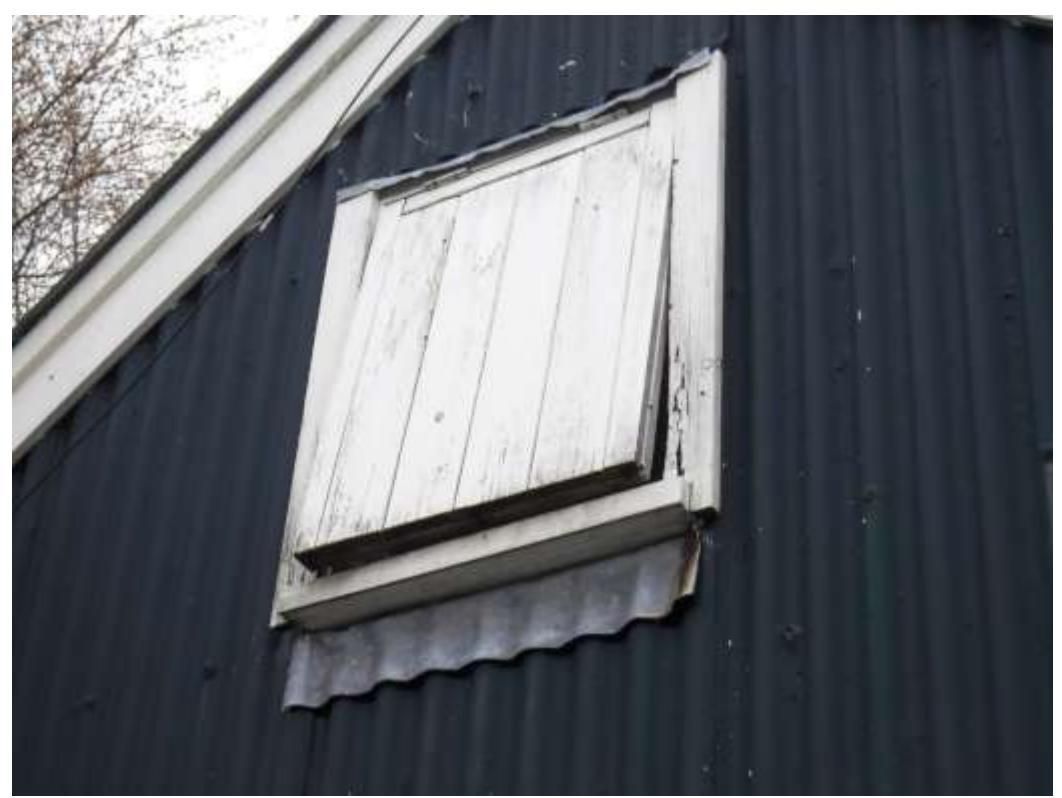
26. Timber decay noted to the high-level window here.

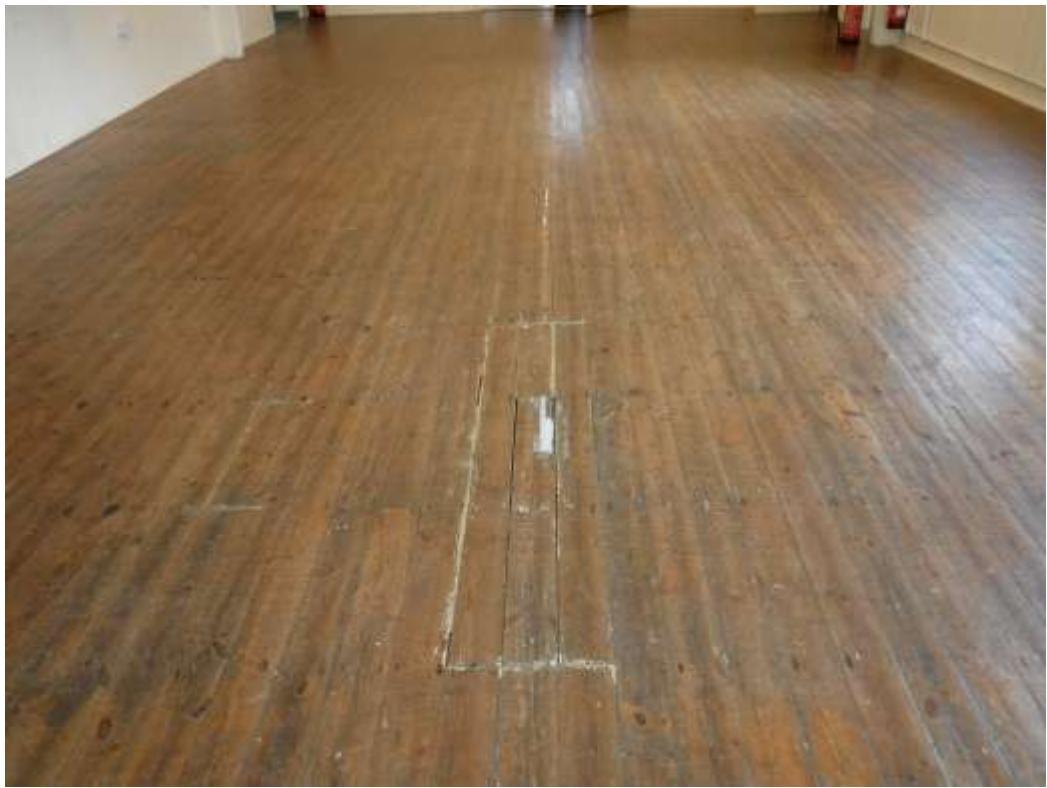
There is some damage on the floorboards, which is not uncommon in this type and age of property. Where an access hatch of sorts has been formed, the work has been done very crudely.

27. Floorboards can be removed here; note poor finishes.

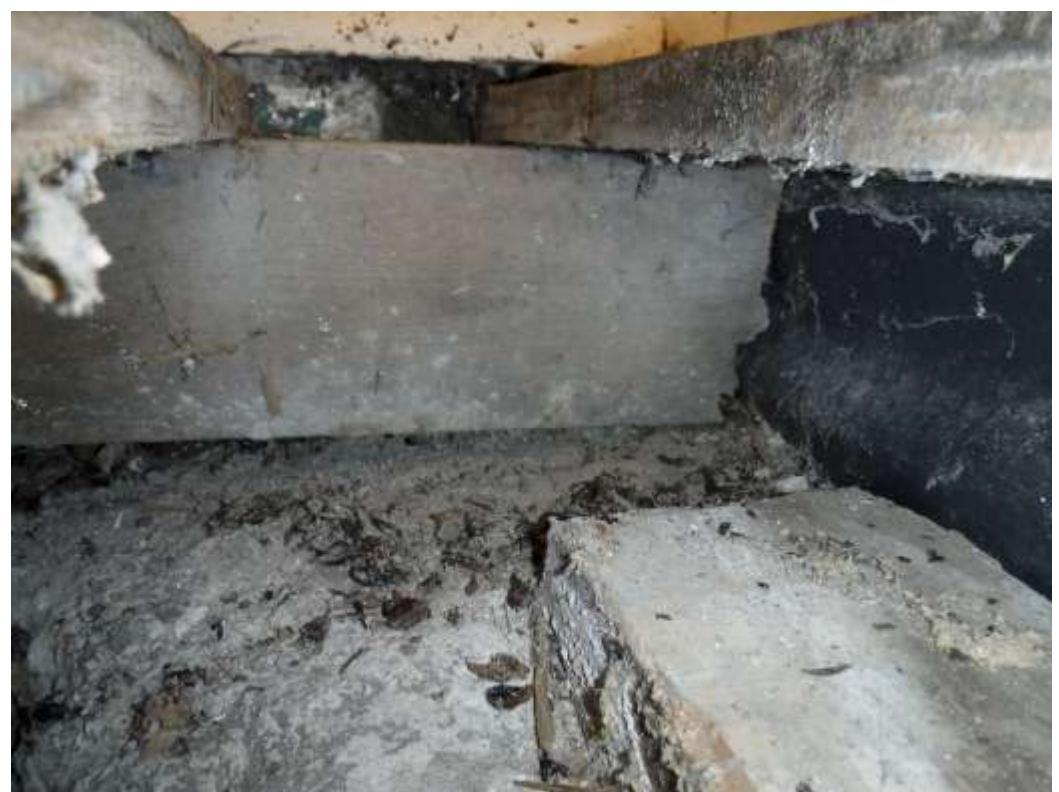
33. Gap noted underneath the floor joist.

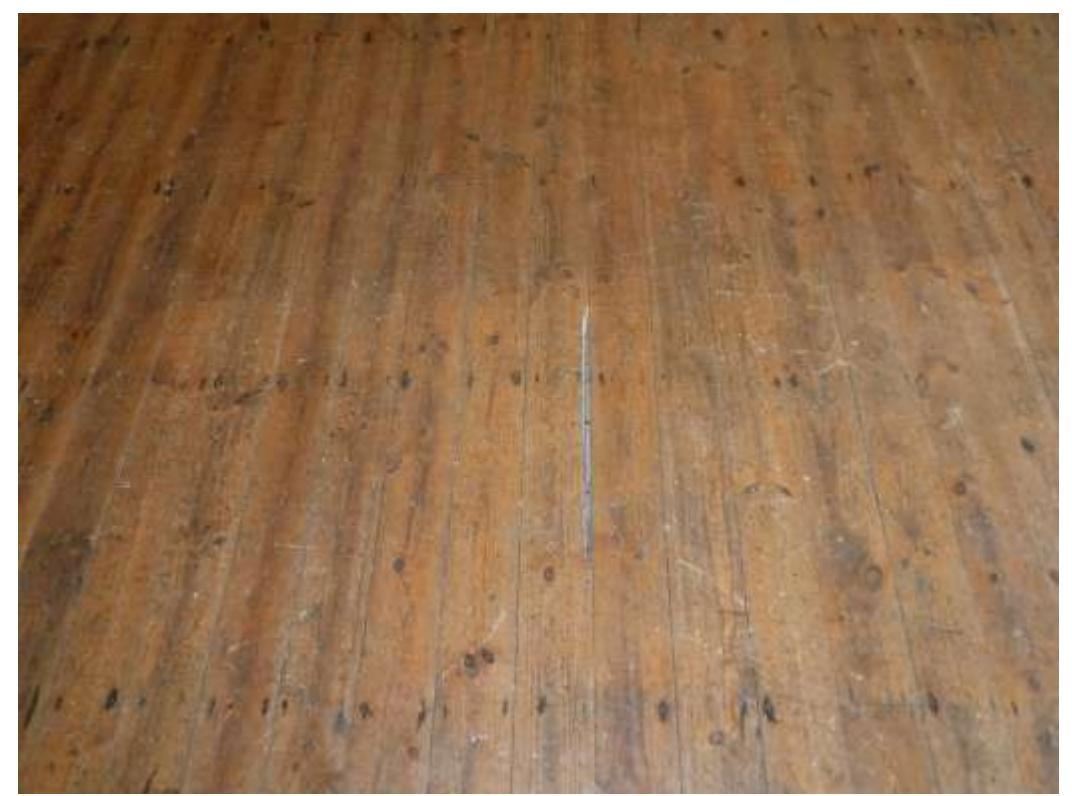
34. An example of damage to floorboards.

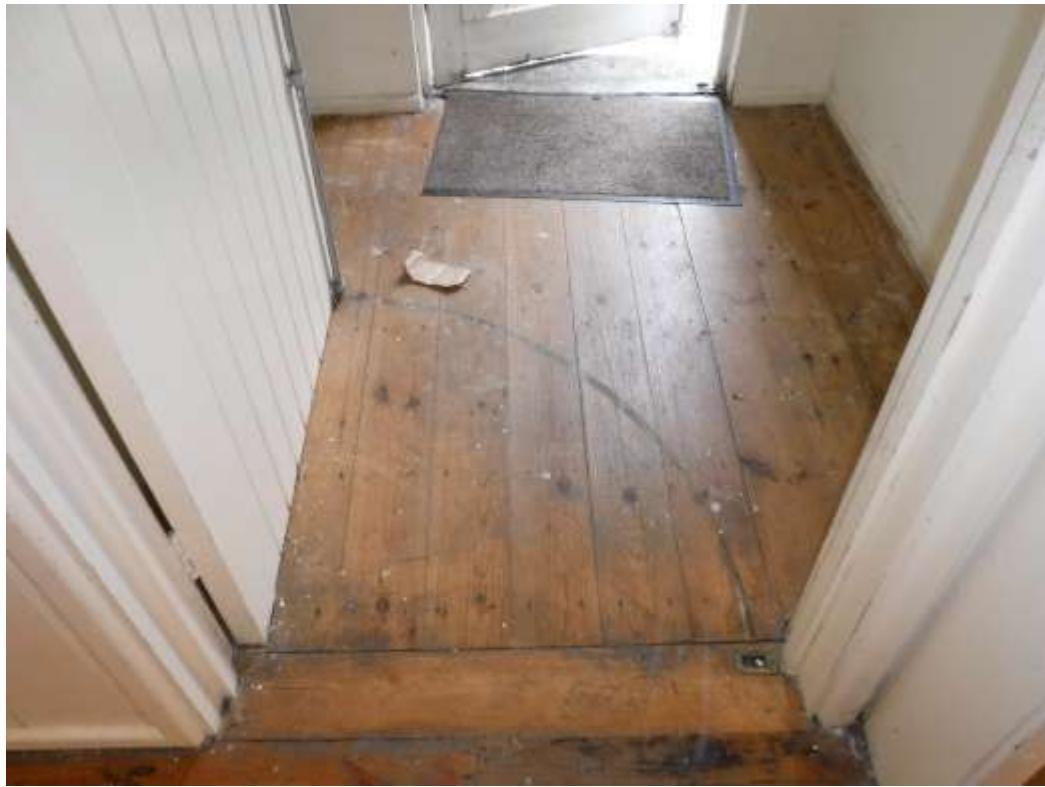
35. This floor has been damaged by the door mechanism here.

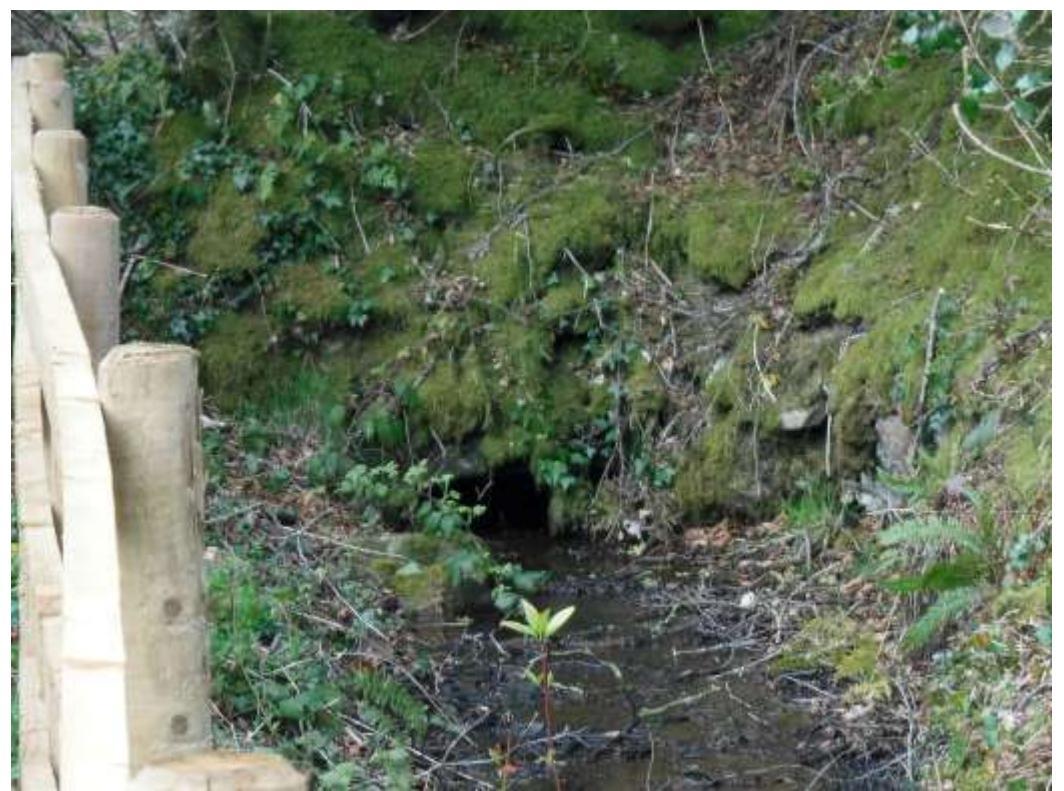
36. This Devon bank bridges over the leat; there is a risk that it could collapse in the future.
